AVIATION INVESTIGATION REPORT

A00P0206

RUNWAY INCURSION

AIRBC LTD.

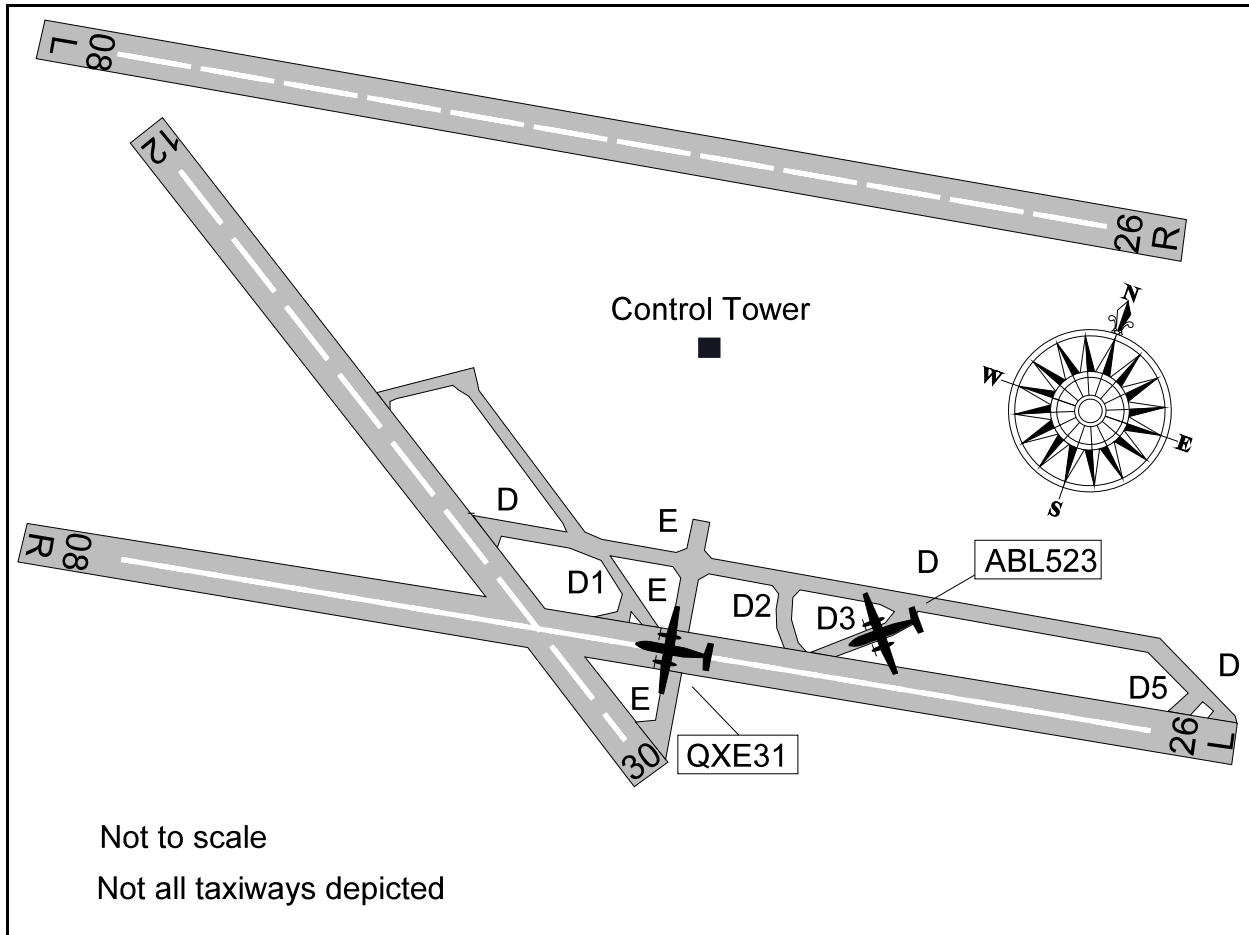
Figure 1. Intersection take-off from runway 26L

A pilot may request an intersection take-off when the full runway length is not needed. Such a request will normally be approved provided noise abatement procedures, traffic, and other conditions permit. QXE31 had requested departure from intersection E, and ABL523 had requested departure from intersection D3.
